# IMPORTANT PRODUCT INFORMATION

**Product: PACSystems™ RX7i CPUs with Firmware Version 2.0**

**IC698CRE020-AA CPU Module (700 MHz)**

This is the initial release of Hot Standby CPU Redundancy for the RX7i Platform.

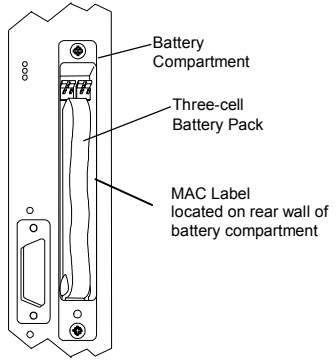
<i>Subject</i>	<i>Description</i>
<b>MAC address</b>	<p>A label on the rear wall inside the CPU's battery compartment identifies the MAC address assigned to the CPU's embedded Ethernet Interface. The label is visible when the battery is removed from its compartment. (The battery does not need to be disconnected to temporarily remove it from the compartment.)</p>

<p>The diagram shows a vertical battery compartment. At the top is the 'Battery Compartment' opening. Below it is a 'Three-cell Battery Pack'. On the rear wall of the compartment, there is a 'MAC Label'.</p>
<b>Configuration of IP Address is Required Before Using Ethernet Communications</b>	<p>The Ethernet Interface within the CPU module cannot operate on a network until a valid IP address is configured. The necessary Ethernet addressing information must be configured prior to actual network operation, or to recover from inadvertent changes to the Ethernet addressing data at the Ethernet Interface. Use one of the following methods to initially assign an IP address:</p> <ul style="list-style-type: none"> <li>■ Connect a serial terminal to the Station Manager port of the PACSystems RX7i . Then use the CHSOSW command to enter the desired IP address. For details, see <i>Station Manager for the PACSystems RX7i</i>, GFK-2225.</li> <li>■ Temporarily assign an IP address to the module using the SetIP tool over the Ethernet network. For details, see <i>TCP/IP Ethernet Communications the PACSystems</i>, GFK-2224.</li> <li>■ The Ethernet Interface automatically obtains a temporary IP Address from a BOOTP server on the network. For details, see <i>TCP/IP Ethernet Communications for PACSystems</i>, GFK-2224.</li> </ul> <p>Once a temporary IP address has been set up, the Ethernet Interface can be accessed over the network (such as by the CIMPLICITY ME programming software). The programmer should then be used to configure the proper IP address for the Ethernet Interface.</p>
